INDEPENDENT FRONT SUSPENSIONS

SERVICE BULLETIN

Spider Bolts on (IFS) Independent Front Suspensions

Holland USA Part Number: 90546687

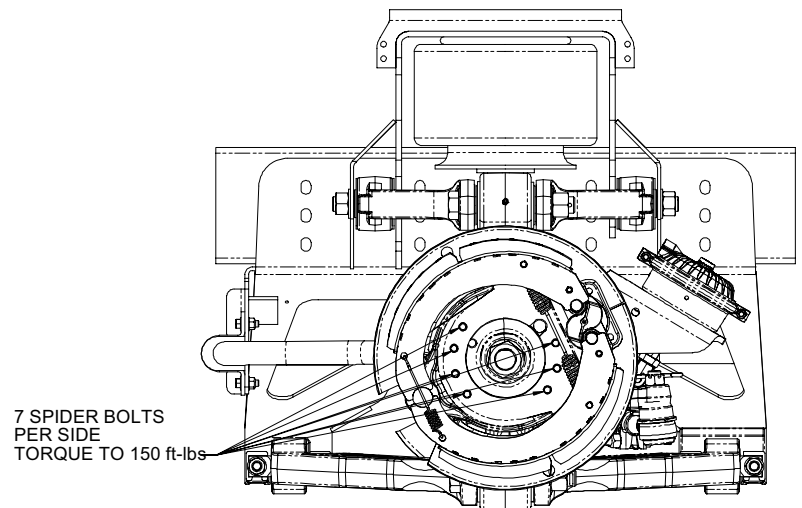
The purpose of this bulletin is to notify you that a potential customer satisfaction issue may exist with the Holland IFS suspension on your Country Coach and National RV vehicles. The bolts that mount the brake assemblies to the front right and left spindle assemblies may not have been tightened to the manufacturer's specified torque values.

If these bolts, referred to as Spider Bolts, were not tightened to the proper torque values they could become loose over time and possibly make a rattling noise. Holland does not believe that this condition will affect the ability of the vehicle to brake or otherwise relates to motor vehicle safety.

Holland USA recommends that all 14 Spider Bolts (7 on each side, see illustration at right) should be checked for proper torque with a torque wrench. The "Work Instructions", including labor reimbursement are found on page 2 of this document and should be completed at the earliest opportunity.

- spider bolts to specified torque (150 ft-lbs) in alternating sequence
