Insufficient Wheel Rim Clearance for SAF-HOLLAND Z9-4218 axle range

This service bulletin has been developed to help identify an offset discrepancy on some imported rims. These rims have been used on the Z9-4218 axle range and has resulted in reports of damage.

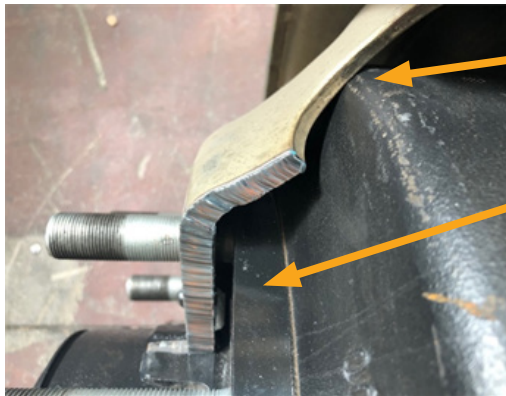
Wheel rim to brake drum clearance insufficient

Rim mounting surface gap, caused due to insufficient clearance of the rim

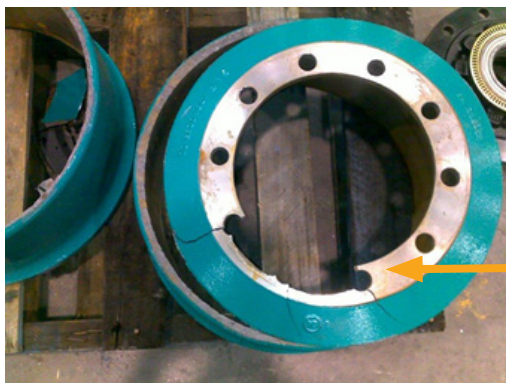
Tightening of wheel nuts resulted in damage to the drum
