GOUPER RECALL SERVICE BULLETIN

CP-400-CA

Draft hook retaining nut recall (NHTSA recall No. 02E-041 for USA and 02-133 for Canada) for CP-400-H and CP-400-CA

July 8, 2002

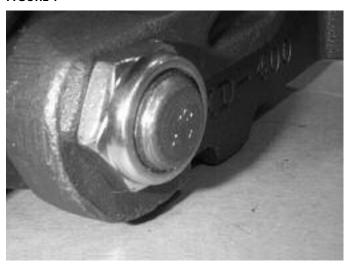
FIGURE 7

4. Tighten the new nut (see *FIGURE 6*) onto the bolt until the nut bottoms out on the coupler housing, as shown in *FIGURE 7*.

- 5. Torque the nut to a minimum of 50 ft-lbs. Make sure that the jaw can still rotate freely on the bolt.
- 6. If you do not have any Loctite you must stake (deform) the exposed threads of the bolt in three places around the bolt, as shown in *FIGURE 8*.
