Shock absorber “Misting” Explained

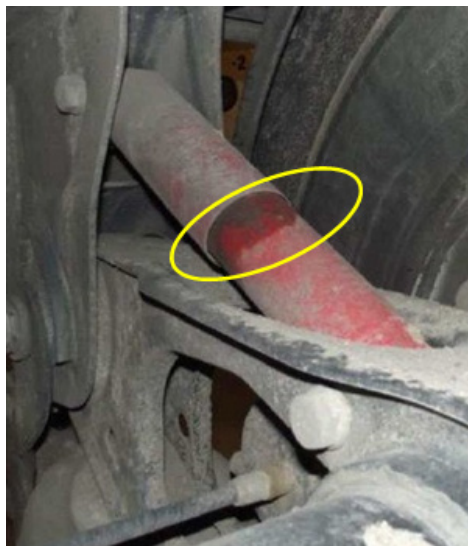
Light oil misting

- A light matte oil film (oil mist) or damp looking area at top of main body
- The outer tube of the shock absorber is dry in the remaining area
- None of the surrounding components are wet with oil

- Leakage of a small quantity of oil which is necessary for lubrication of the piston rod seal escapes as a vapour under heavy operational requirements

- None
- This has no effect on the damping forces or the service life.
- There is no reason to replace the shock absorber.

Tip: In case of doubt the shock absorber should be cleaned and assessed again after a test run in dry driving conditions. A discernible increase in temperature of the shocker after the test run is a good indication of a normally functioning shock absorber.

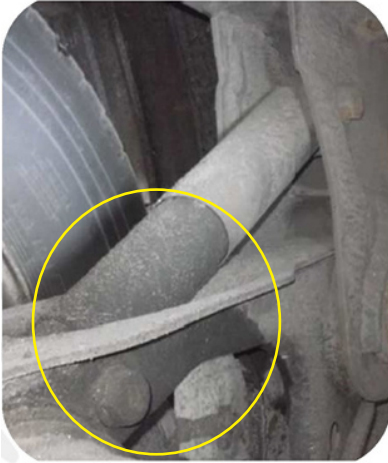
Seal failure

- The outer tube is wet with a shiny oil film over large areas
- Adjacent components are also oiled
- Adhered soiling has a dark colour over the length of the shocker base and or surrounding components

- Seal damaged
- Surface damage on the piston rod
- Ride height outside the configuration

- A replacement is necessary

Tip: If multiple shock absorbers (more than 50%) on one vehicle have the same type of fault, the ride height should be checked to ensure proper operation.
