For some time now, "one-piece" copy brake discs with the SAF-HOLLAND reference numbers

04 079 0013 03 (22.5") 04 079 0010 04 (19.5")

Tel. +49 6095 301-301 · originalparts@safholland.de · 2011-04-28 · XL-SA10060WI-en-DE Rev A · Page 1 of 4

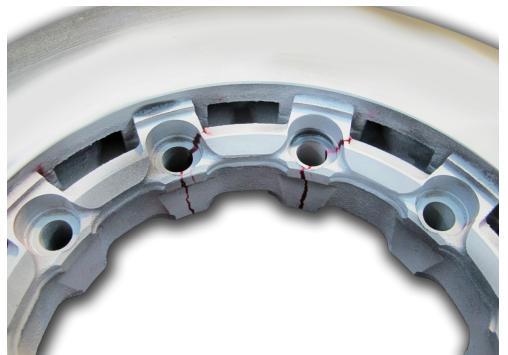
Figure 1: Continuous tension cracks in the area of the through-holes as the one-piece manufacture of the brake discs

In a standardized performance test in accordance with GLOBAL SPEC VC (planned ISO-Standard 15484) and disc brake comparison test in accordance with ISO/DIS 26865 (point 6.4) by a certified testing company (HONEYWELL Bremsbelag GmbH) tension cracks did in fact occur in the area of the through-holes (mounting) on these one-piece INTEGRAL copy disc brakes, which can lead to a complete component failure and thus also to brake failure (see attached images).

This, according to current findings, is the basis for a **safety risk**, because a sufficient brake performance can no longer be guaranteed. In addition, blocking brakes can, for example, have a negative impact on vehicle stability and brake pieces which break and fall off can represent a danger to others. Because, according to the information we currently have available, a danger from the one-piece INTEGRAL copied brake discs cannot be completely ruled out, we advise that the utmost caution be used in this regard.

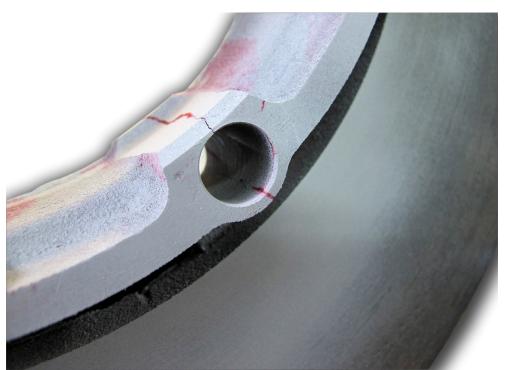
Figure 2: Continuous tension cracks in the area of the through-holes as the one-piece manufacture of the brake discs

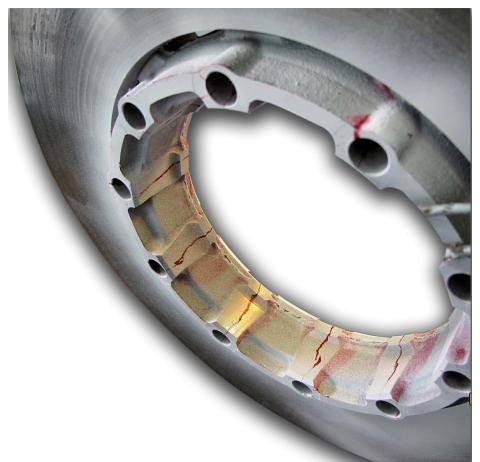
Figure 3: Continuous tension cracks in the area of the through-holes as the one-piece manufacture of the brake discs
