GOUBAFETY RECALL SERVICE BULLETIN

CP-400-CA

Draft hook retaining nut recall (NHTSA recall No. 02E-041) for CP-400-H and CP-400-CA

July 8, 2002

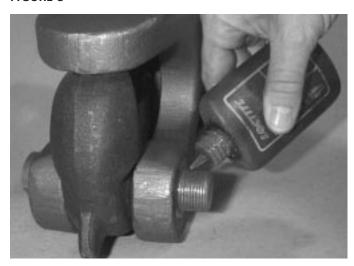
FIGURE 5

3. Add one drop of Locktite permanent thread locker #277 (or Permatex large diameter thread locker – Red) to the threads of the bolt as shown in *FIGURE 5*.

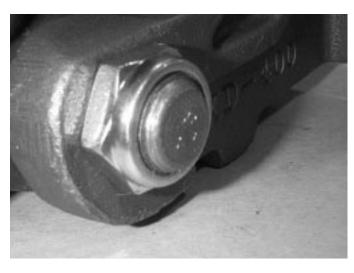
FIGURE 7

4. Tighten the new nut (see *FIGURE 6*) onto the bolt until the nut bottoms out on the coupler housing, as shown in *FIGURE 7*.

- 5. Torque the nut to a minimum of 50 ft-lbs. Make sure that the jaw can still rotate freely on the bolt.
- 6. If you do not have any Loctite you must stake (deform) the exposed threads of the bolt in three places around the bolt, as shown in *FIGURE 8*.
